PUBLIC INFORMATION STATEMENT
NATIONAL WEATHER SERVICE RALEIGH NC
357 PM EDT MON APR 18 2011

...TORNADO CONFIRMED NORTH OF BURLINGTON IN ALAMANCE COUNTY NORTH CAROLINA...

LOCATION...NORTH OF BURLINGTON IN ALAMANCE COUNTY NORTH CAROLINA
DATE...APRIL 16 2011
ESTIMATED TIME...206 PM EXITING THE COUNTY AT 216 PM
MAXIMUM EF-SCALE RATING...EF1
ESTIMATED MAXIMUM WIND SPEED...110 MPH
MAXIMUM PATH WIDTH...200 FEET
PATH LENGTH...7.5 MILES IN ALAMANCE COUNTY
BEGINNING LAT/LON...36.17N / 79.45W
ENDING LAT/LON...36.25N / 79.35W
* FATALITIES...0
* INJURIES...0

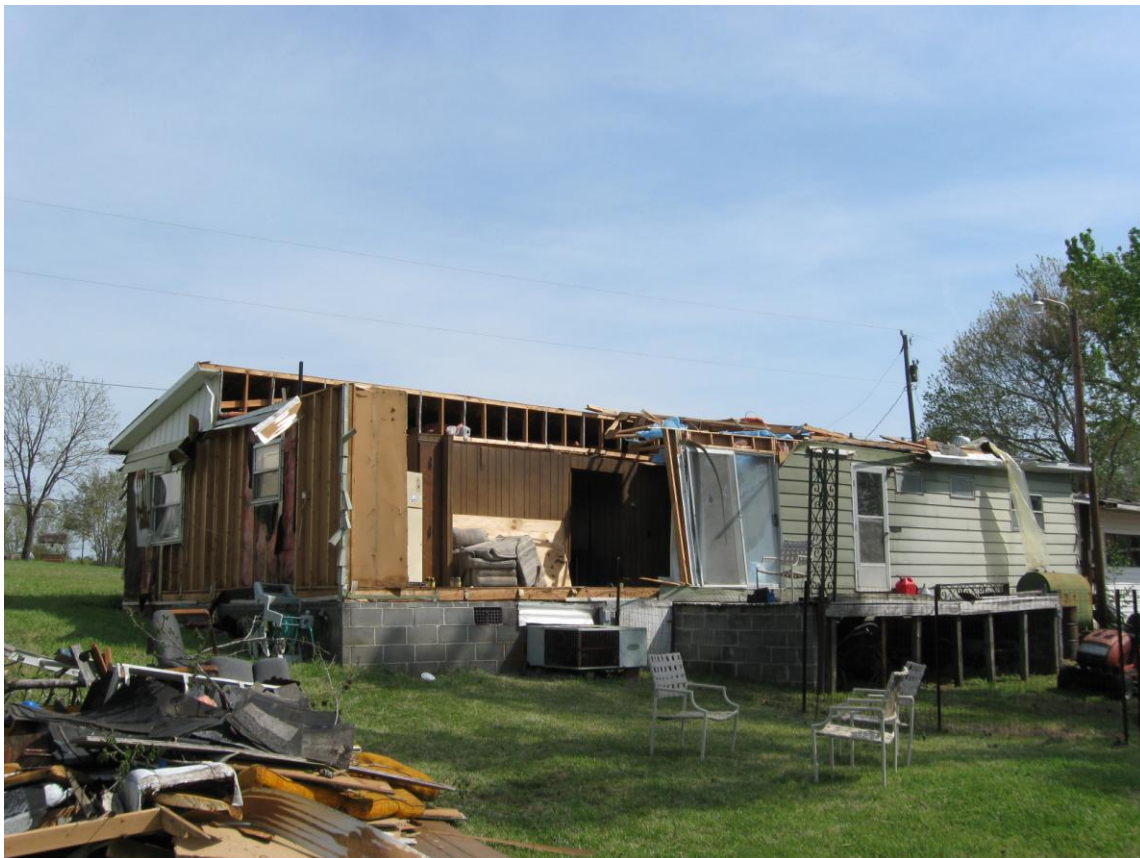
On Altamahaw Union Ridge Road.

THE TORNADO CONTINUED UP ALTAMAHAW UNION RIDGE ROAD WHERE A HOME HAD ONE WALL COLLAPSE. WINDS THEN BLEW THROUGH THE HOME AND BLEW OUT THE ATTACHED GARAGE WALL. THE ROOF OF THE HOME WAS DEPOSITED ALONG THE STORM TRACK AND ACROSS THE STREET. THE HOME ACROSS THE STREET LOST WINDOWS AND HAD A PORTION OF ITS ROOF REMOVED. SNAPPED AND DOWNED TREES IN THE AREA COVERED A WIDTH OF APPROXIMATELY 200 FEET IN THIS AREA.

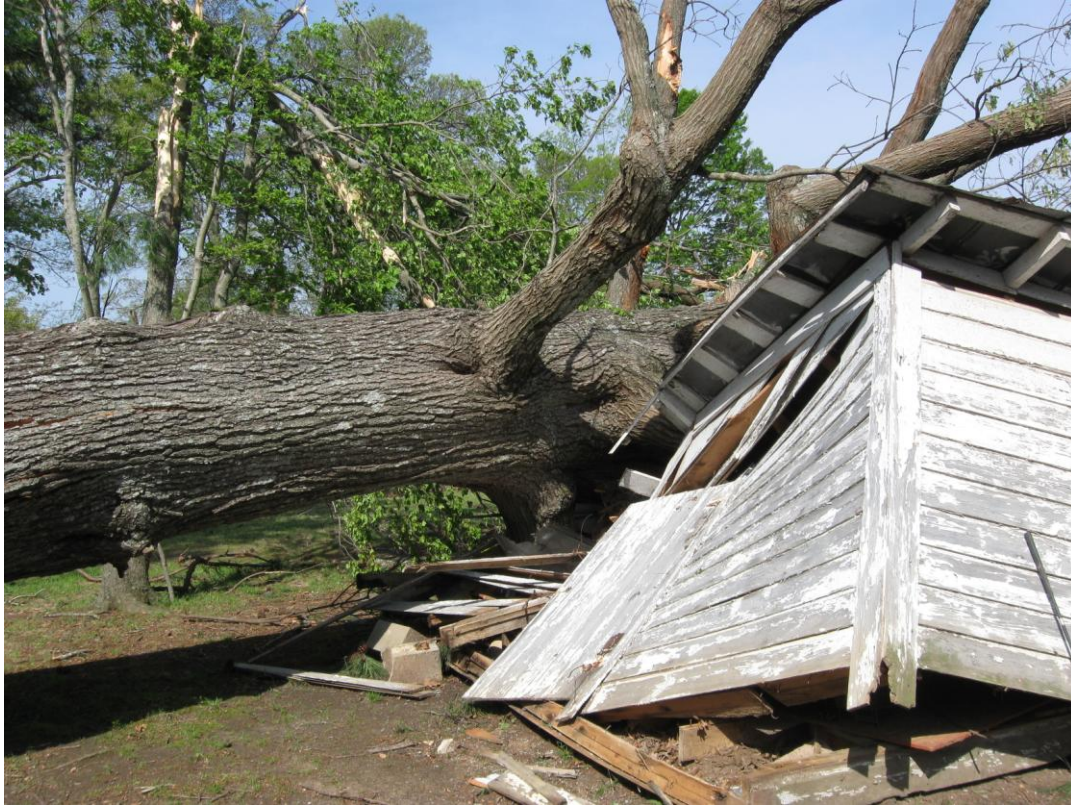
On Aunt Mary's Road.

THE TORNADO FIRST TOUCHED DOWN AT BETHEL METHODIST CHURCH ROAD... SNAPPING SOME TREES THIRTY FEET OFF THE GROUND AND UPROOTING SEVERAL LARGE TREES. THIS INITIAL DAMAGE WAS RATED EF0. DAMAGE ALONG THE REMAINDER OF THE TRACK IS RATED EF1. SIMILAR BUT SLIGHTLY HEAVIER DAMAGE WAS NOTED ON AUNT MARY'S ROAD INCLUDING THE UPROOTING OF A FOUR FOOT DIAMETER OAK. THE ROOF WAS BLOWN OFF A TWO STORY RESIDENCE.

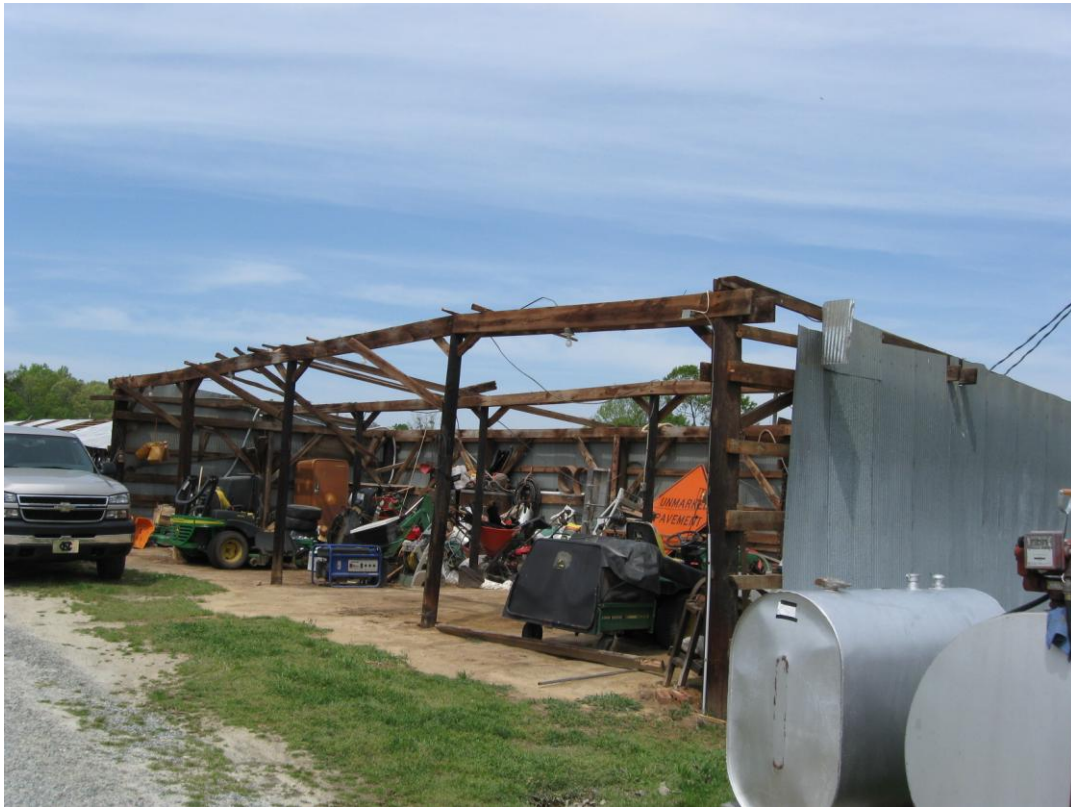
On Union Ridge Road.

THE TORNADO CONTINUED NORTHEAST... PARALLELING UNION RIDGE ROAD. SEVERAL RESIDENCES RECEIVED ROOF DAMAGE ALONG THIS ROAD WITH MANY TREES SNAPPED OR UPROOTED. THE TORNADO EXITED THE COUNTY JUST EAST OF UNION RIDGE ROAD... DAMAGING A RESIDENCE. THE ROOF WAS PARTIALLY REMOVED. ONE NEARBY STORAGE SHED WAS HEAVILY DAMAGED AND A SECOND TOTALLY DESTROYED. THE ROOF OF A NEARBY FEED BARN WAS DEPOSITED 350 YARDS ACROSS AN OPEN FIELD.
